41321 / 41322 / 41323
2001-02 GMC Sierra HD, Denali, Sierra C3# PU – Bolt Over Logo Covered

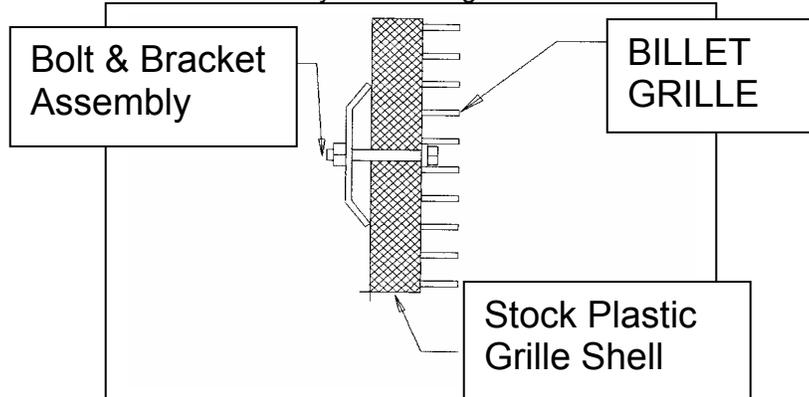
Step 1: Center billet grille in opening. Use bolts, nuts and brackets supplied and attach per illustration below.

Step 2: Check to make sure the grille is properly in place and tighten the bolts just enough to hold the grille in place.
DO NOT OVER TIGHTEN as this may cause the grille shell to crack.

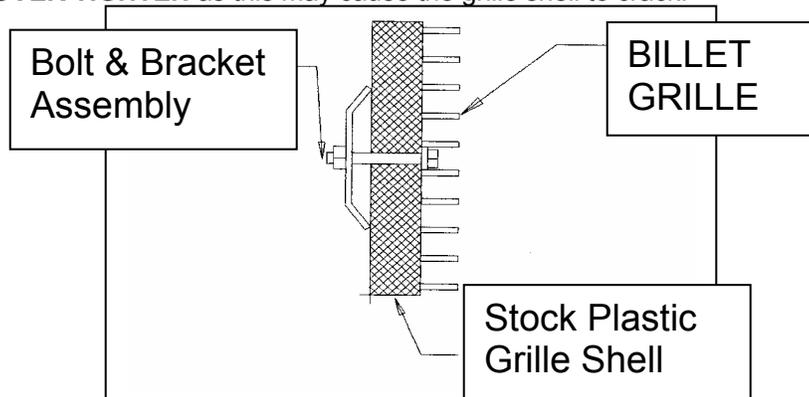
Step 1: Center billet grille in opening. Use bolts, nuts and brackets supplied and attach per illustration below.

Step 2: Check to make sure the grille is properly in place and tighten the bolts just enough to hold the grille in place.
DO NOT OVER TIGHTEN as this may cause the grille shell to crack.
