# 2006 Nissan 350Z 1-piece bumper grille

**PART# 42821(Brushed) - 42822(Polished) - 42823(Black) Upper**

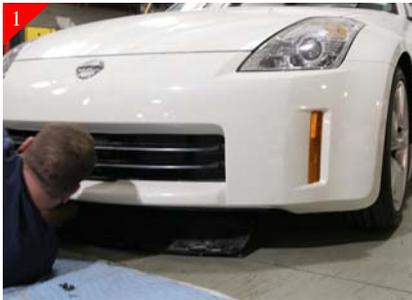
Remove (12) 10mm bolts from splash guard located under front of vehicle as shown. Also remove the (1) plastic rivet to allow splash guard to come down.

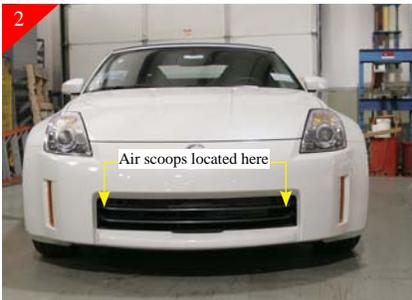
Remove air scoops from behind stock grille shell by removing (3) plastic push pull rivets then remove air scoop. Make sure to keep the air scoops you will re-install them a little later.

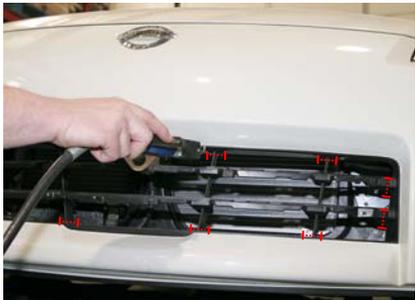
Before cutting center portion of grille shell, tape the front end using masking tape to protect. Using a air saw or hack saw cut the center portion of stock shell as shown above following RED dotted lines to aid in cutting. Make sure to leave material so you can come back and do finish sanding.

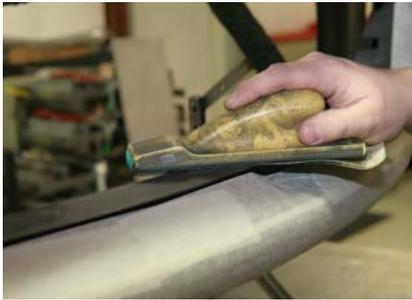
Sand all cut areas smooth using a sanding block.

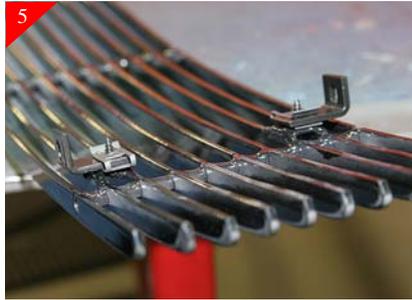
Place supplied u-clips on brackets and then attach brackets to billet grille using the supplied #8 x 5/8" Phil pan head screws as shown above.

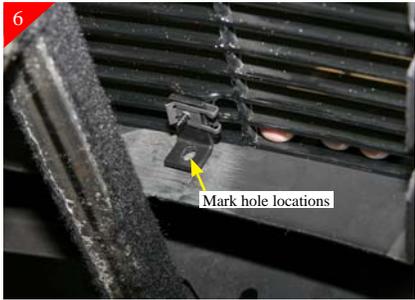
Place billet grille into opening and center. Next mark the hole location using a scribe. Shown above in the backside of the billet grille to show marking of brackets.

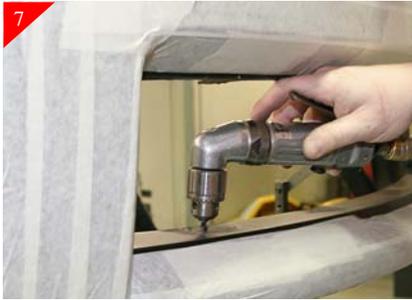
Remove billet grille from opening and also remove the brackets from the billet grille. Now drill a 3/16" hole in each of the just marked locations as shown above.

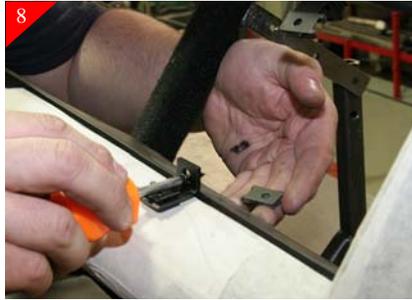
Attach bracket by placing a u-clip on the under side of the just drill holes. Then attaching bracket to the u-clip using the supplied #8 x 5/8" phil pan head screws. Then attach billet grille to the brackets using #8 x 5/8" Phil pan head screws.
