# 2003-06 GMC

(1-piece Bumper mounts behind the 2-hole opening)

**PART# 43161(Brushed) - 43162(Polished) - 43163(Black)**

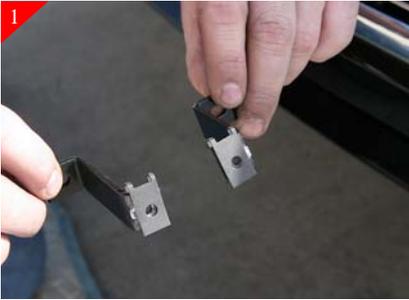
- 2 - Brackets
- 2 - U-clips
- 2 - 1/4-20 x 1" Bolts
- 2 - 1/4-20 Nyloc Nuts

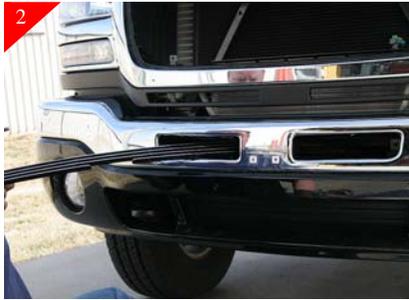
If you already have the upper billet grille installed (Part#4186). You will need to remove it by unscrewing the #8 x 5/8" Phil pan head screws holding billet grille in place. Next place supplied U-clips on brackets as shown above.

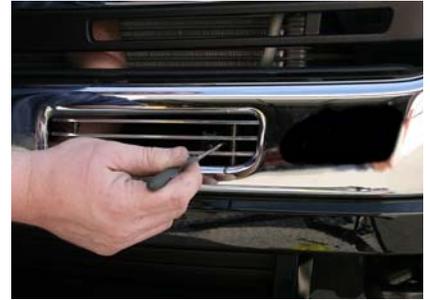
Place billet grille into opening as shown above. Then reaching from the top opening attach the brackets to the backside of the billet grille using the supplied #8 x 5/8" Phil pan head screws. Take note that you will not be able to place the billet grille into the opening if you attach the brackets first.

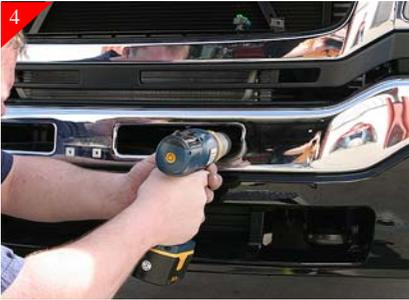
With brackets attached, center billet grille in opening. Using a scribe mark the hole locations in the brackets where they meet vehicle as shown above. After marking let the billet slide down out of the way, but leave it in the opening.

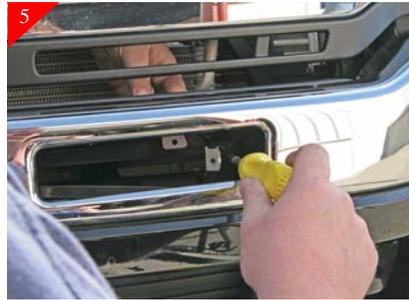
Starting with a 9/32" drill bit drill in the just marked locations. Then switch to a 3/16" drill bit and again drill in the just drilled locations. It is recommended to start with a smaller drill bit when drilling.

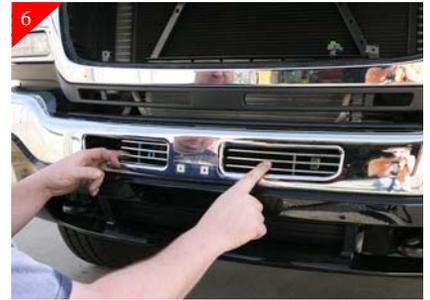
Attach one of the brackets to vehicle using the supplied 1/4-20 x 1" bolt and 1/4-20 Nyloc nuts.

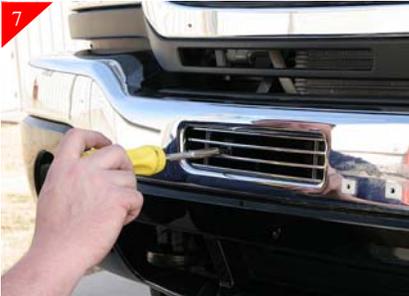
Slide the billet grille over and past the just place brackets as shown above. This allows you to attach the other bracket to the vehicle using the supplied 1/4-20 x 1".

Center the billet grille over the brackets and attach billet grille to brackets using the supplied #8 x 5/8" Phil pan head screws.
